Aiken Home Inspections

Building Inspection Report

Address: 4127 SOMEPLACE RD,
ANYTOWN, NY 23456

Report Number: 20070516

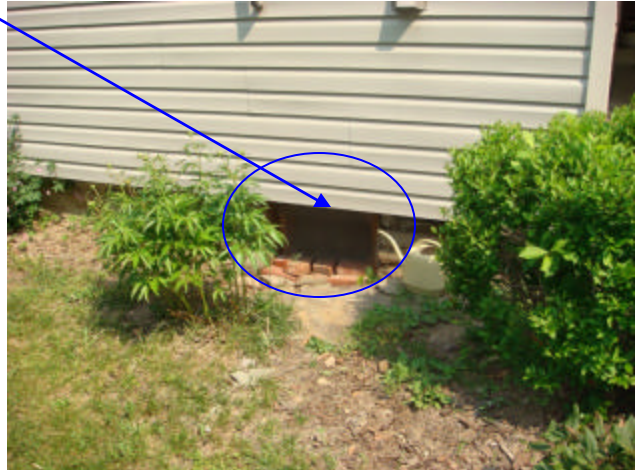
Floor insulation is not present. I recommend you consider installation of insulation to save energy and installing a vapor barrier on the ground in this space.

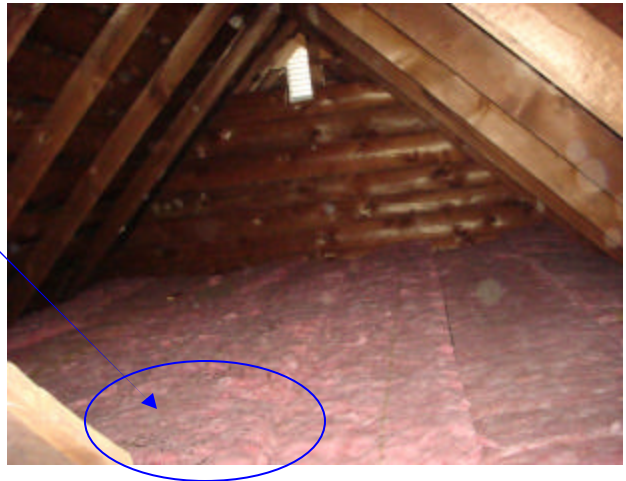
Investigate Further Evidence of rodent activity was observed in the attic. Rodents can damage duct work and wiring and can be a health hazard. Extermination is needed. Contact a pest control firm or deal with the problem yourself by placing traps in areas of known activity.

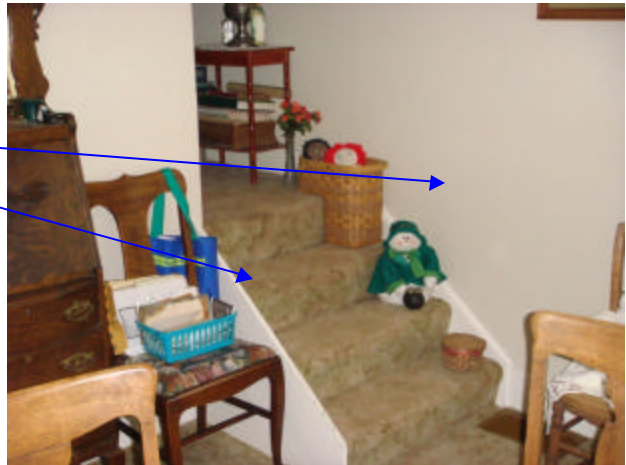
Safety Concern Some of the steps and stairs have no handrails. I recommend the installation of handrails for safety reasons. Falling on steps and stairs is one of the primary causes of injury in the home.

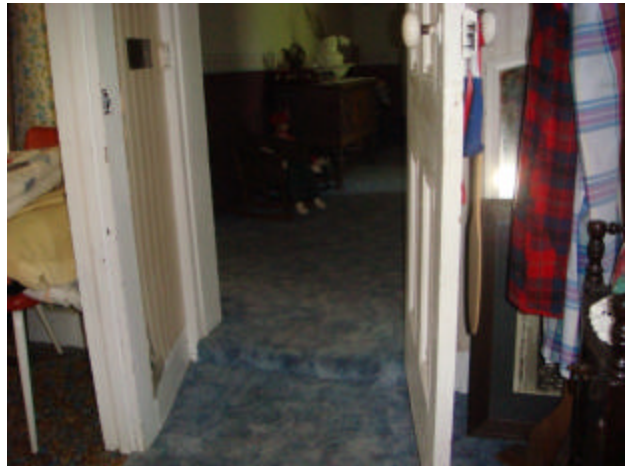
Safety Concern The transition from the second floor hallway to the landing at the top of the stairs has the door swinging out over the landing towards the stairs. This may be a safety concern if the door is in the closed position and opened with the person not expecting a change in floor transition
