Aiken Home Inspections

Building Inspection Report

Address: 4127 SOMEPLACE RD,
ANYTOWN, NY 23456

Report Number: 20070516

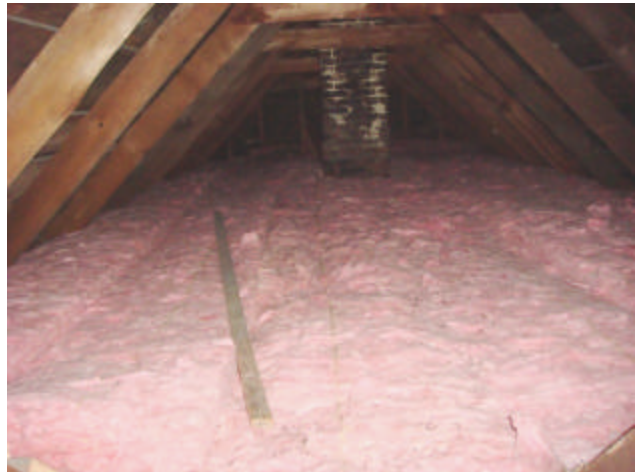
Insulation attic R- Value of 30+ is typical for houses in this climate. The insulation R- Value for the other areas of the house is typical for houses this age. This attic has an insulation R-Value of 38.

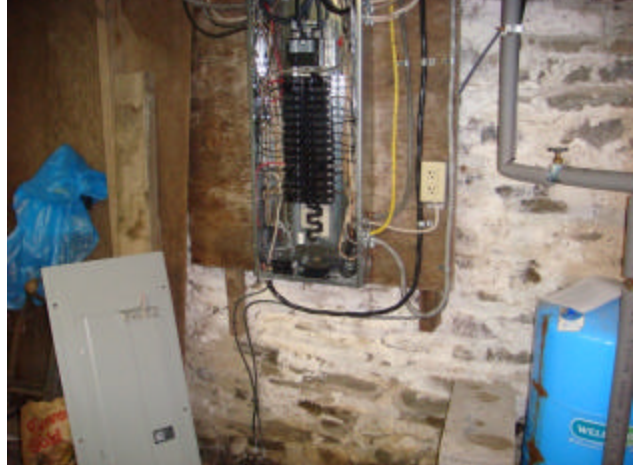
The readily visible wiring is a mixture of original and newer copper in non-metallic cable.

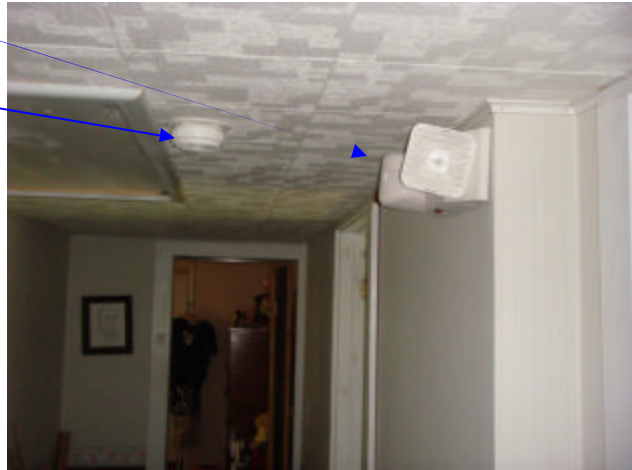
The second floor is equipped with emergency lighting and a hard wired smoke detector.

Smoke detectors should be installed (if not already present) on each floor (including attics and basements.) Modern standards require that smoke detectors be installed inside and outside of all sleeping areas. They should be hard wired and have battery backups. All smoke detectors should be interconnected so that they all sound at once. We recommend upgrading to this level of protection (if not already present.)
